# Investigative Report

November 17, 2022

RE: Structural Evaluation  
Old Bank Building  
101 Highway 124  
Hallsville, MO 65255

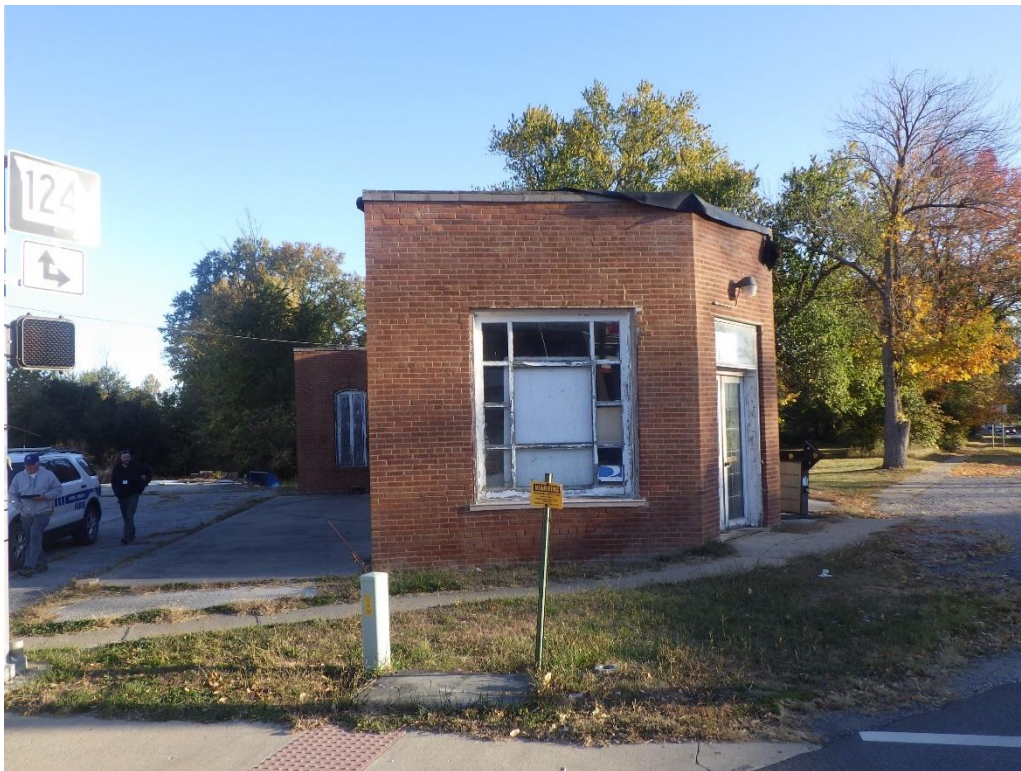
The structure was a single-story, multi-wythe, unreinforced brick masonry building on a crawlspace foundation (Image A). The north portion of the structure had unreinforced clay tile walls. The structure had wood-framed floor and roof assemblies. The mono-slope roof was covered with ethylene propylene diene monomer (EPDM) roofing and drained toward the north. For reference, the front of the structure faced south (Image B).

Image B: Front of the subject structure.

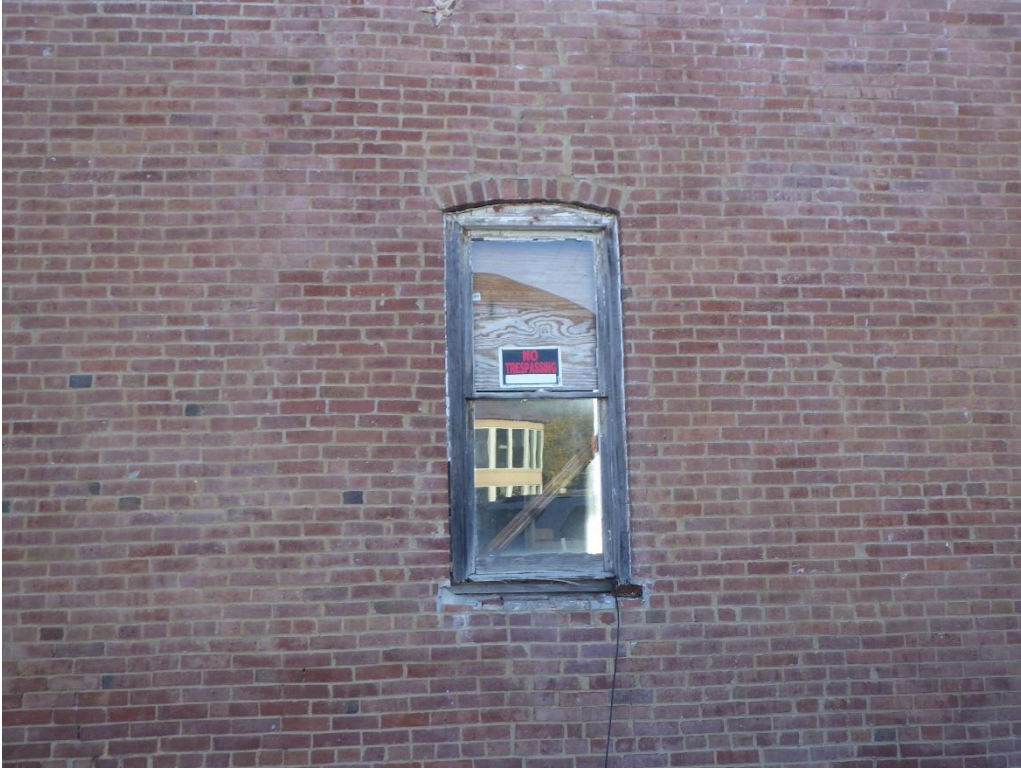
1. The wood windows and doors around the structure were deteriorated at several locations (Image 1). Some of the windows had been boarded shut.
2. Three original lateral wall ties and two newer or additional ties were located along the top of the east wall (Image 2). Three original wall ties and one additional tie were located along the top of the west wall.
3. The brick masonry at the south wall was bulged outward along the head of the window around the east jamb (Image 3). The outward translation of the brick had been repointed.
4. All of the exterior walls had been repointed in the past (Image 4).

Image 1: Degraded west window.

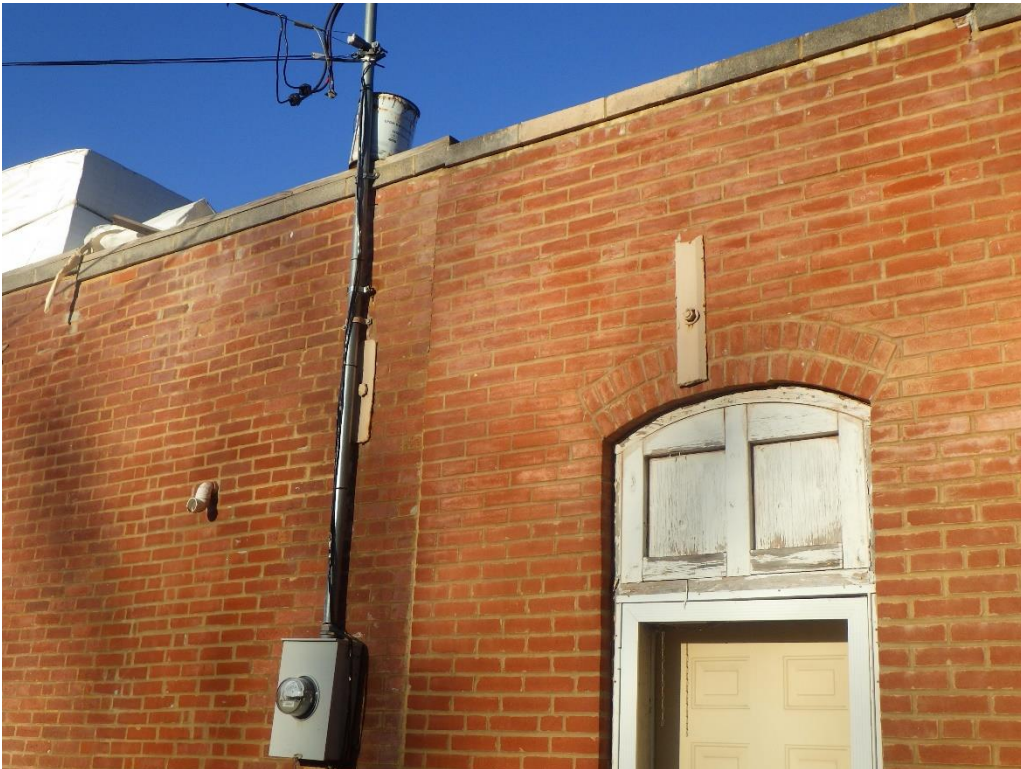
Image 2: Newer lateral wall ties at east wall.

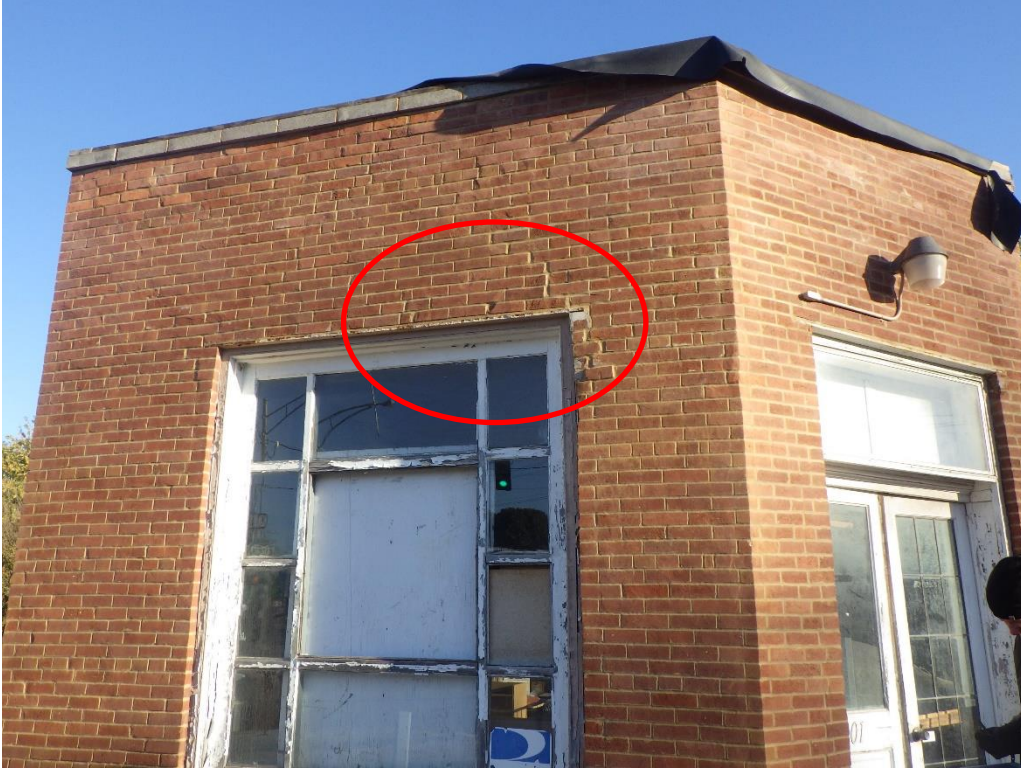
Image 3: South window bulged outward.

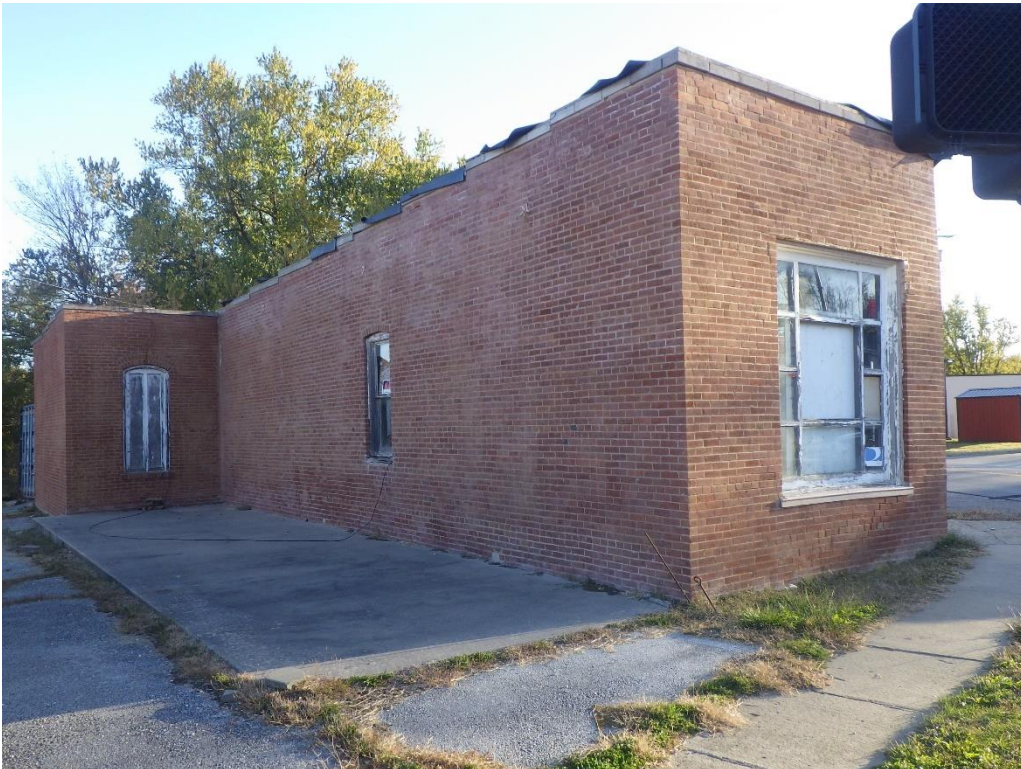
The brick and clay tile masonry walls had been repointed at the exterior, however these bearing walls were severely degraded at numerous locations at the interior. Unreinforced masonry bearing wall buildings with long-term moisture related damage have little redundancy. Thus, immediate failures both at isolated locations and more widespread locations in the structure are possible.

Image 4: Repointed exterior walls.

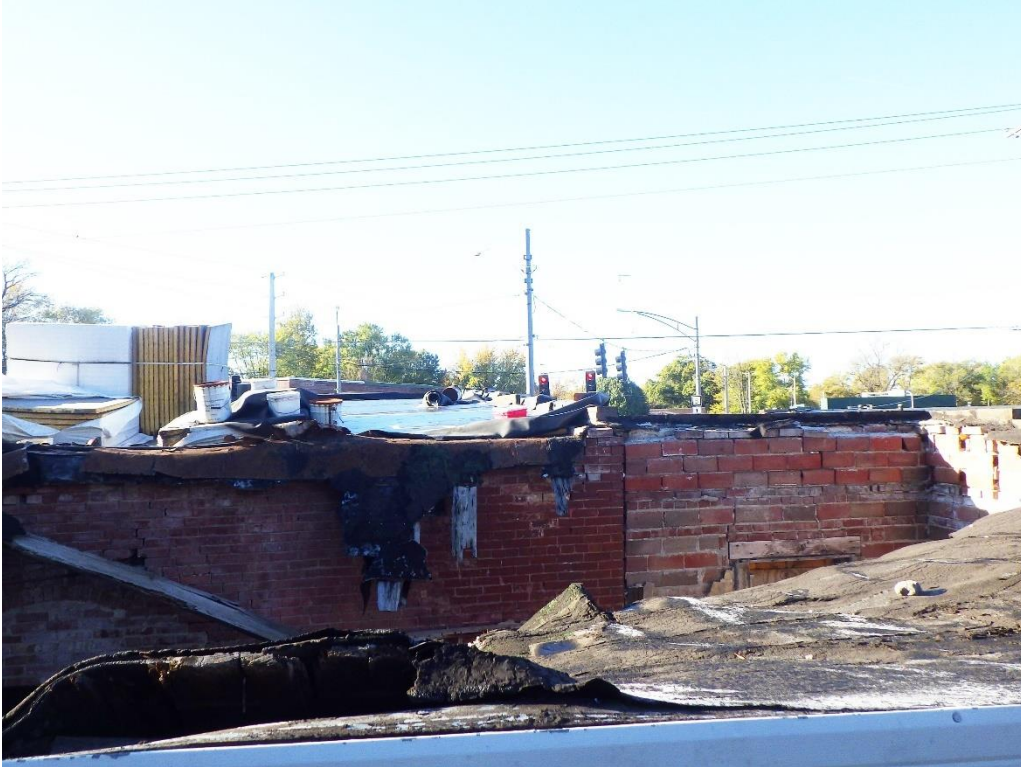
5. The entire north portion of the roof had collapsed and was missing (Image 5).
6. The top of the masonry walls were exposed at the north portion of the structure due to the collapsed roof (Image 6).
7. Newer EPDM roofing had been in the process of being installed along the south portion of the structure (Image 7). The roofing was not finished/secured along the parapets. Roofing material (i.e., insulation board, etc.) was stockpiled on the roof.
8. The west wall at the north portion of the structure appeared to have been leaning outward or toward the west at the top between the lateral wall ties (Image 8).

The majority of the roof at the north portion of the building had collapsed allowing stormwater to readily enter the structure. The north, east, and west walls were degraded at the interior and were not laterally supported at the top. The wood-framed floor assembly was also severely deteriorated and had collapsed throughout the majority of the space.

Image 5: Collapsed north roof – looking south.

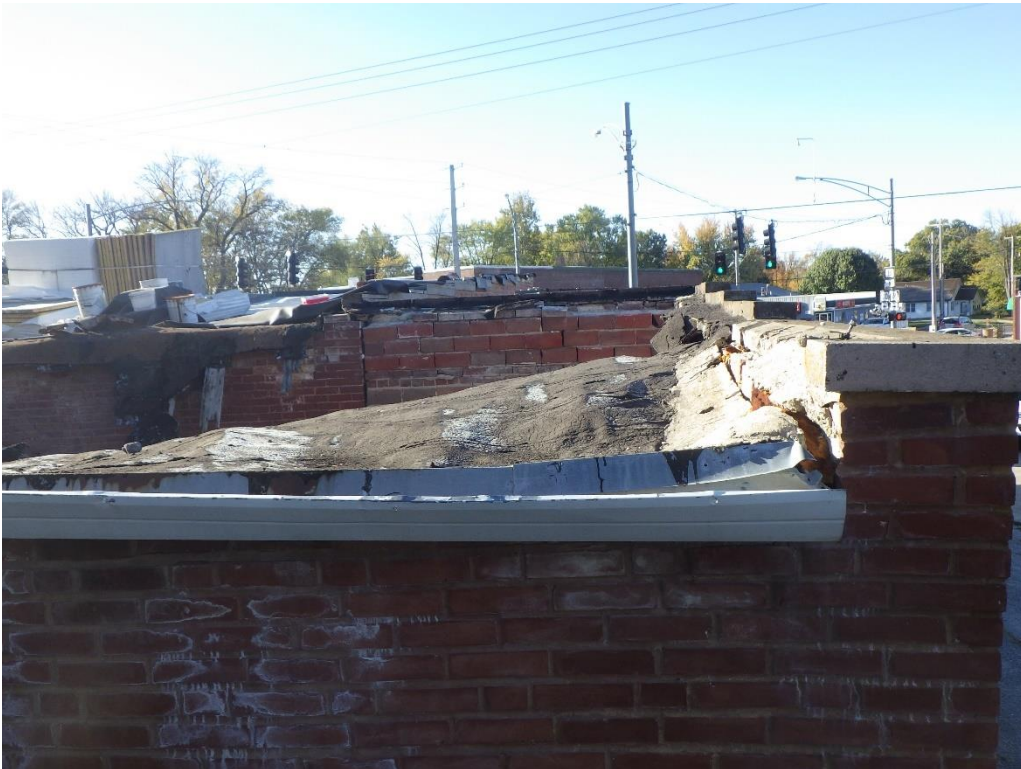
Image 6: Exposed walls – looking south.

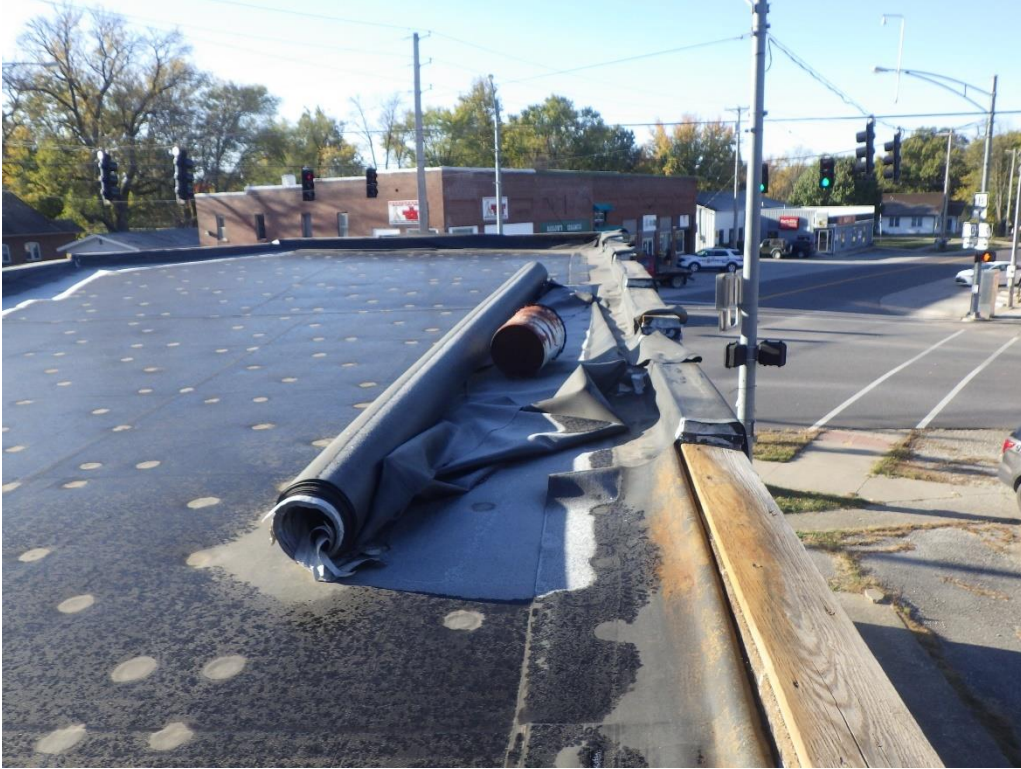
Several of the windows were damaged and/or had been boarded. The roofing at the south portion was never finished and allowed moisture to readily infiltrate inside the structure along the walls. Moisture infiltration likely occurs through other areas of the building envelope as well due to its overall degraded condition.

Image 7: Roofing not finished along the parapets – looking south.

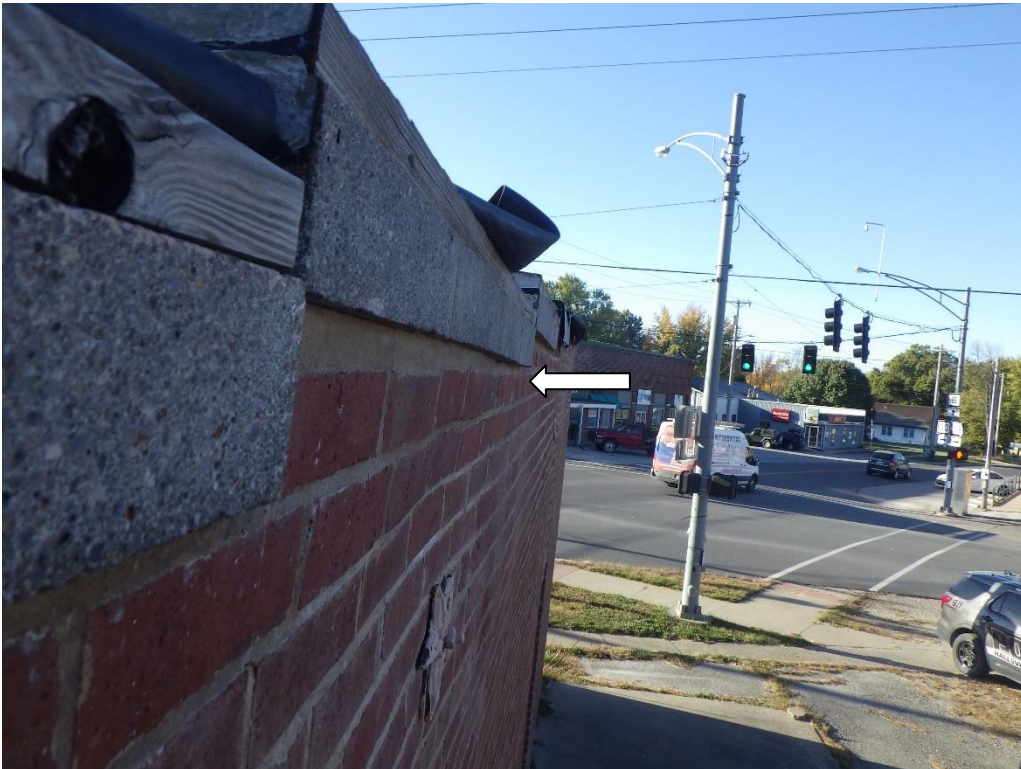
Image 8: West wall leaning outward.

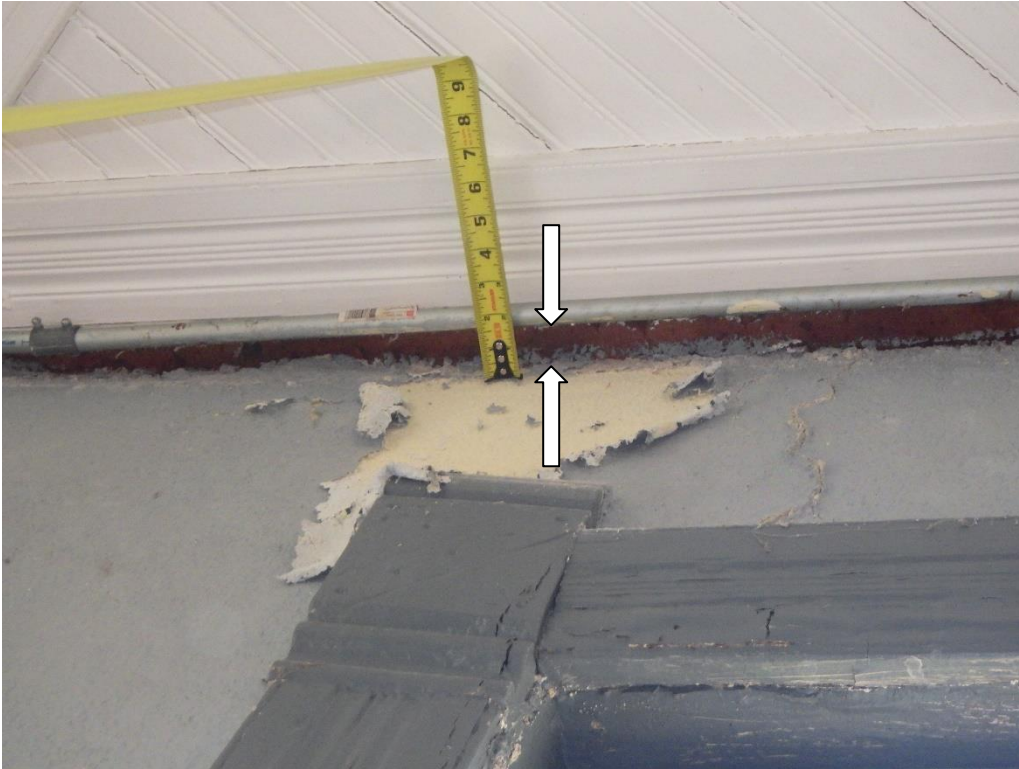
9. A separation of approximately 1 1/2" was observed between the top of the south exterior wall and the ceiling trim (Image 9). This area was adjacent to the bulged brick that was identified in Item 3.

Image 9: Separation at ceiling along south wall.

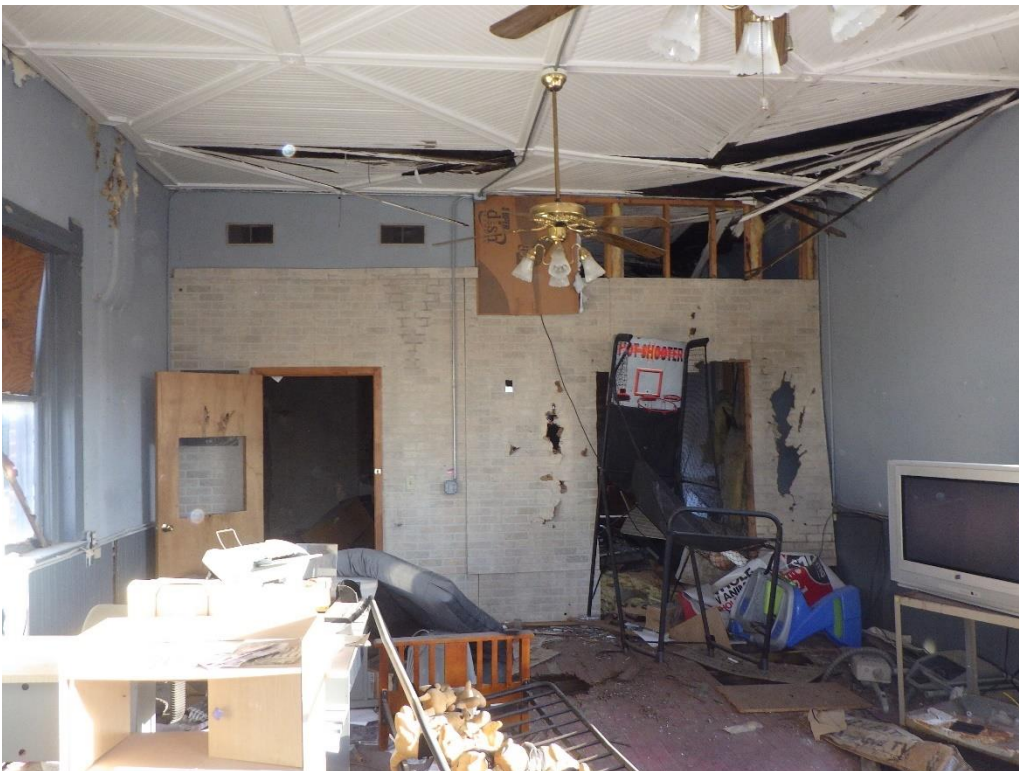
10. The space was in disarray with debris and rubbish throughout (Image 10). Nearly all of the interior finishes were degraded, damaged, or missing.
11. The wood-framed floor was severely deteriorated with several open areas or holes in the floor (Image 11-A). This condition was more severe at the north end of the space (Image 11-B).

Image 10: Interior in disarray – looking north.

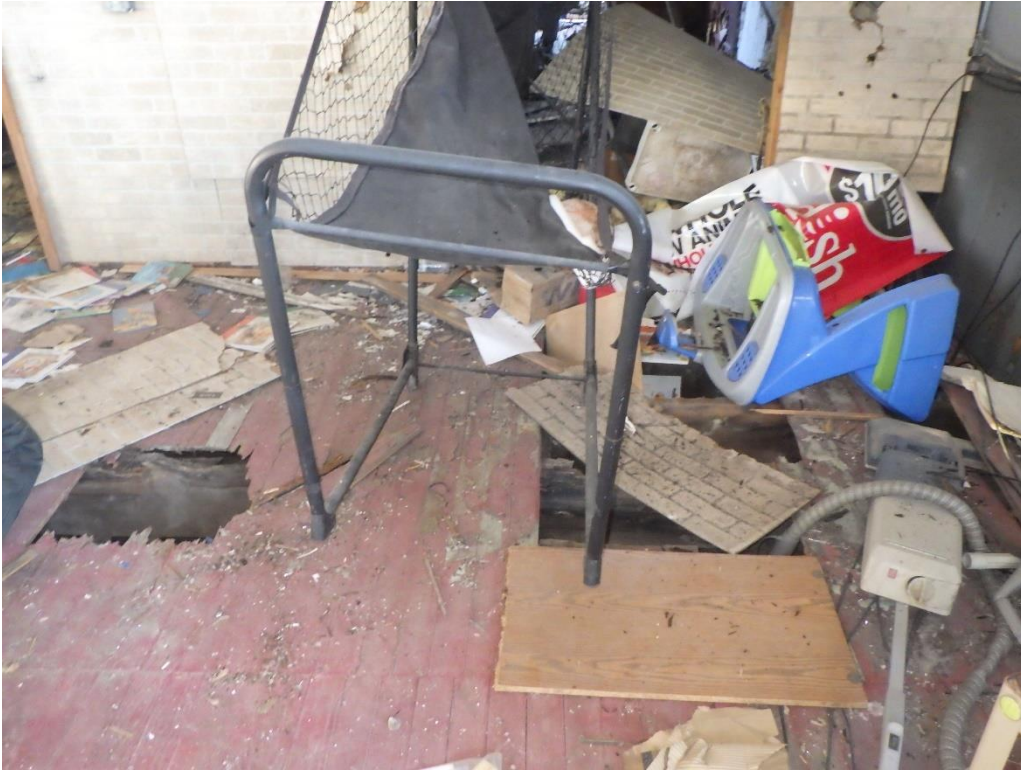
Image 11-A: Holes in the floor.

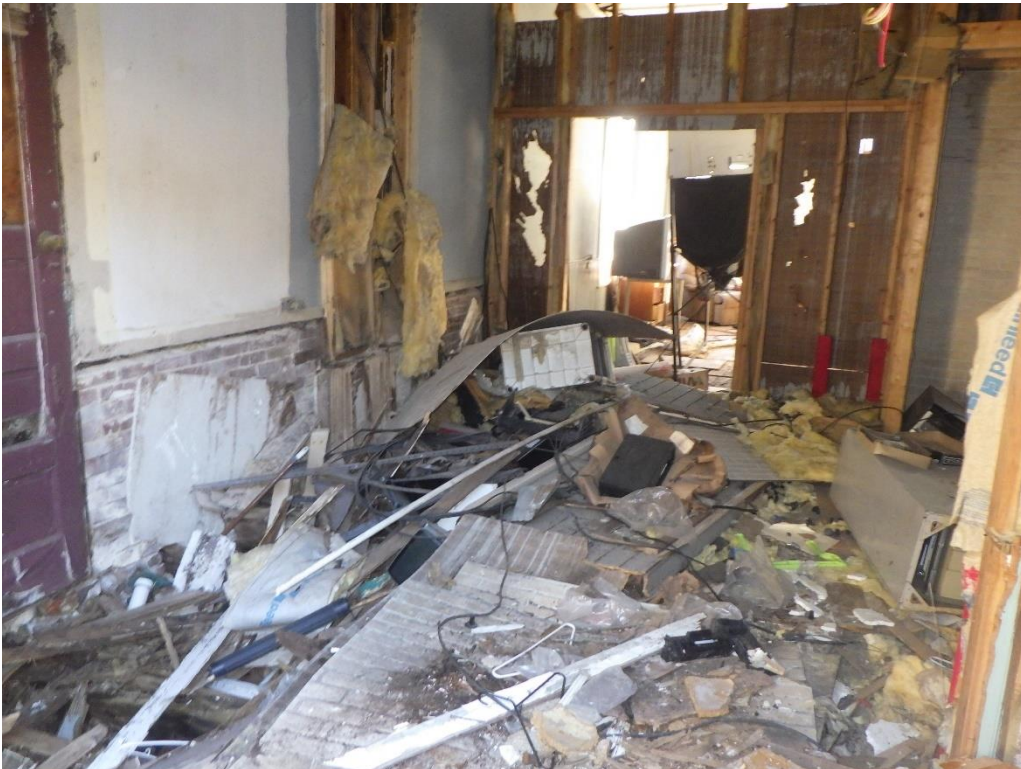
Image 11-B: Holes in the floor at north end.

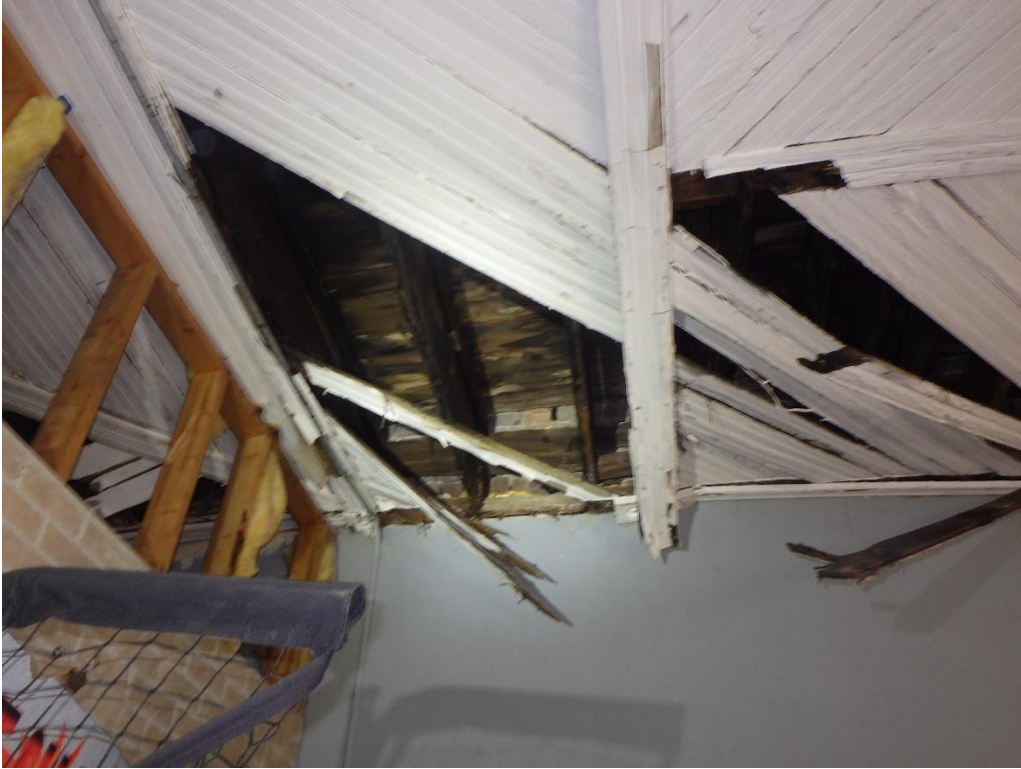
12. The ceiling had partially collapsed at the north end and along the east side of the space. The roof joists above this area were severely degraded (Image 12).

The ceiling and roof framing assemblies in the south portion were severely damaged from apparent long-term moisture exposure at visible areas along the east and west walls. The east and west brick walls at this area did not appear to have been supported laterally. The south wall had also translated outward at the top. Due to the partially finished condition of the structure, the extent of the ceiling/roof framing deterioration was not readily visible. The wood-framed floor assembly was also severely deteriorated and had collapsed at several locations.

Image 12: Deteriorated ceiling/roof joists at east wall.

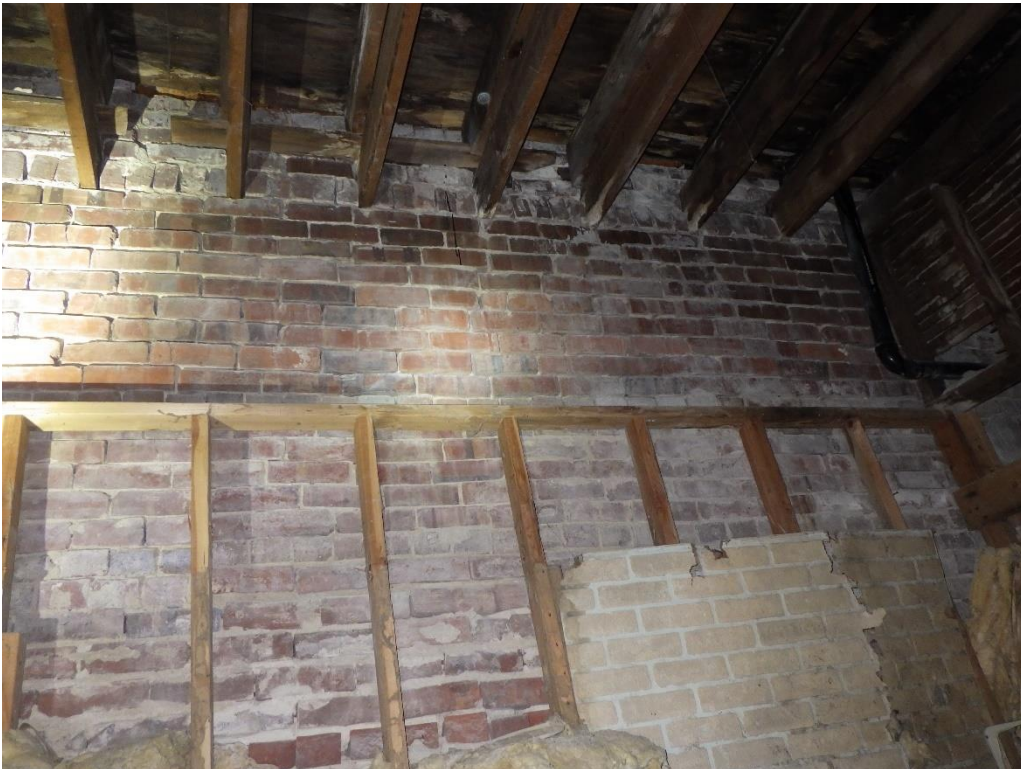
13. The west exterior brick wall was severely degraded at the north end along the top (Image 13).
14. The roof sheathing (planks) were severely degraded at the center of the structure along the west wall (Image 14).

Image 13: Degraded condition of the west wall.

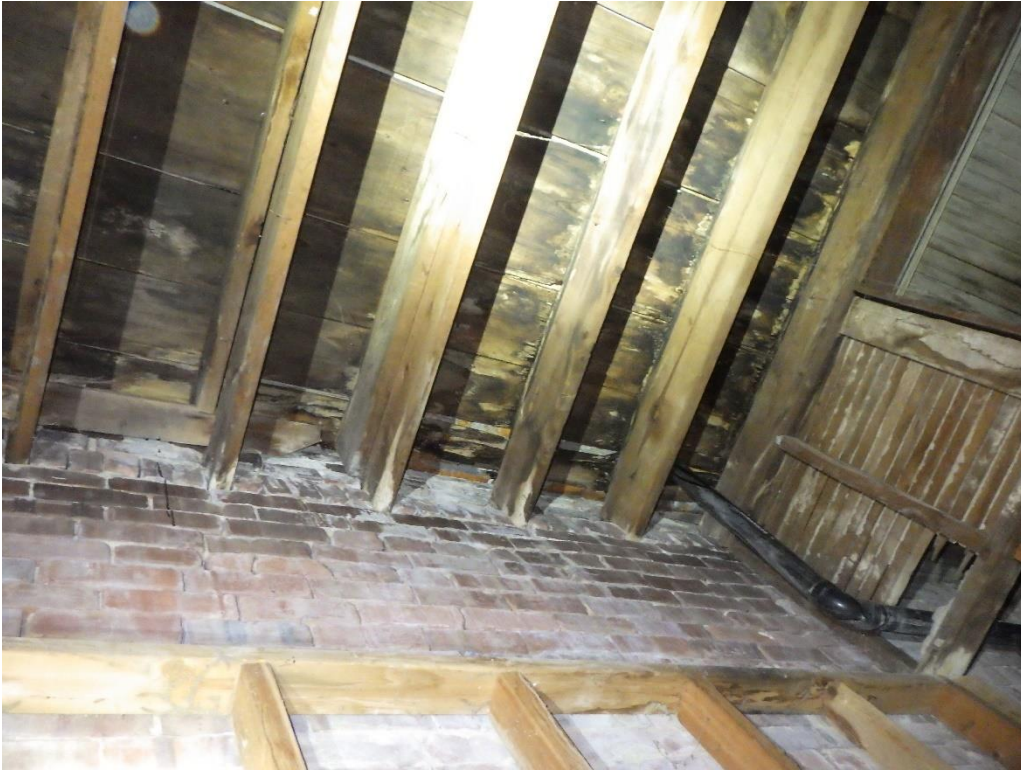
Image 14: Degraded roof sheathing along the west wall.

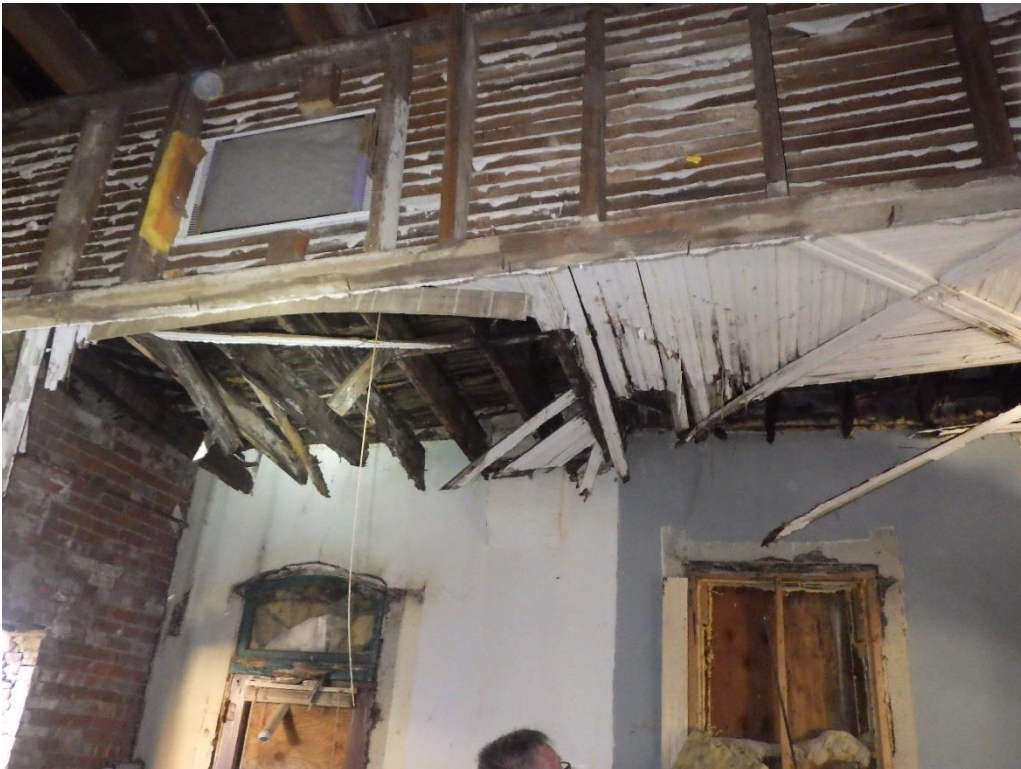
15. The roof joists were severely degraded and were not bearing on the east wall at the north end of the structure (Image 15-A). The interior non-load bearing wall was supporting this portion of the roof from collapse (Image 15-B). The east exterior wall was not laterally braced.

Image 15-A: Severely deteriorated joists along the east wall.

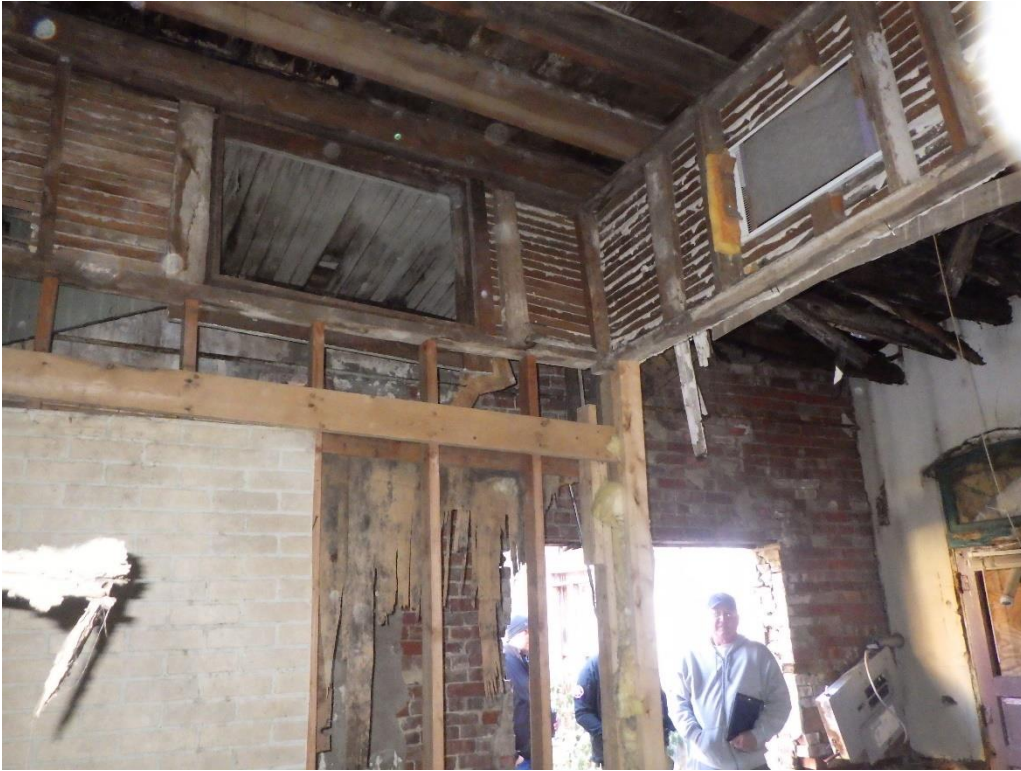
Image 15-B: Interior wall supporting the roof.

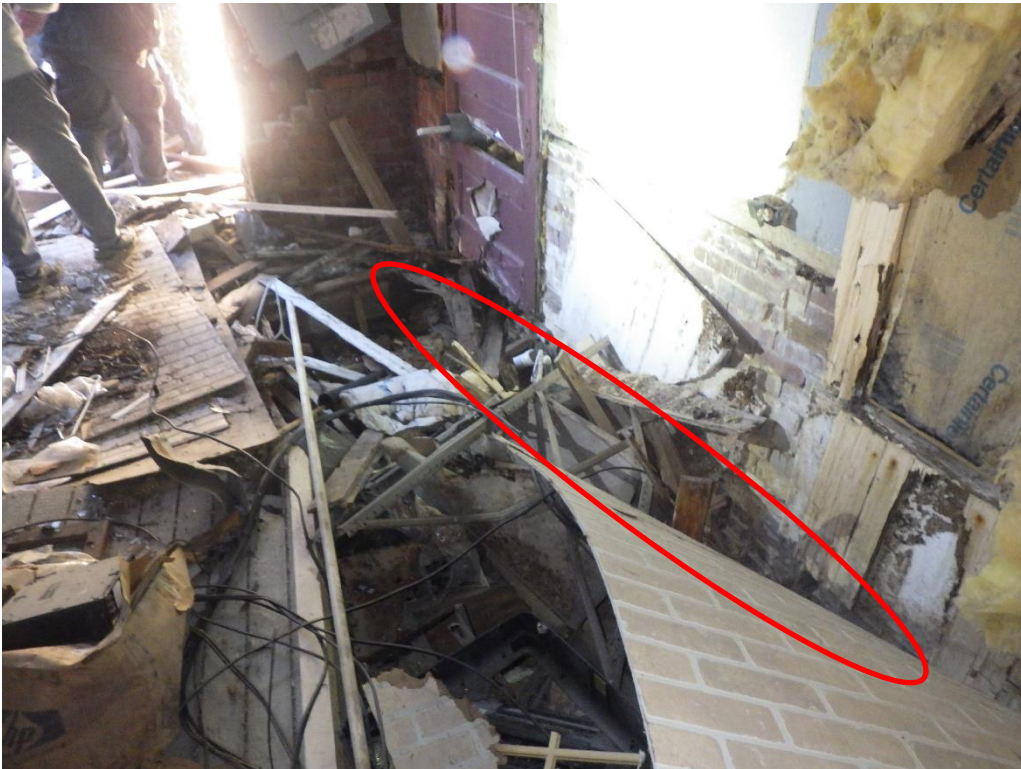
16. The floor structure at the north end was missing along the east wall (Image 16). A portion of the east wall was visible at this area and appeared to have been undermined.

Image 16: East partially undermined wall.

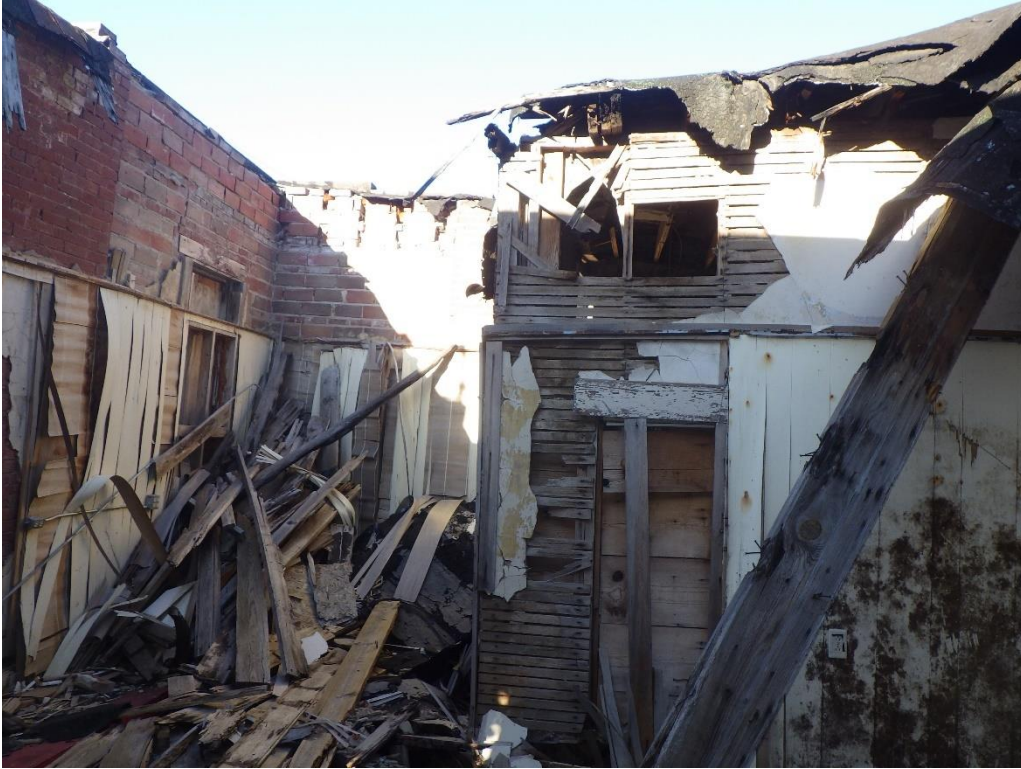
17. The majority of the ceiling/roof assembly had collapsed and was missing (Image 17).
18. The majority of the wood-framed floor assembly had collapsed and was missing (Image 18).
19. The north, east, and west walls were unsupported at the top due to the collapsed ceiling/roof assembly (Image 19).
20. The north, east, and west walls were degraded along the top (Image 20).

Image 17: Collapsed ceiling/roof at north structure.

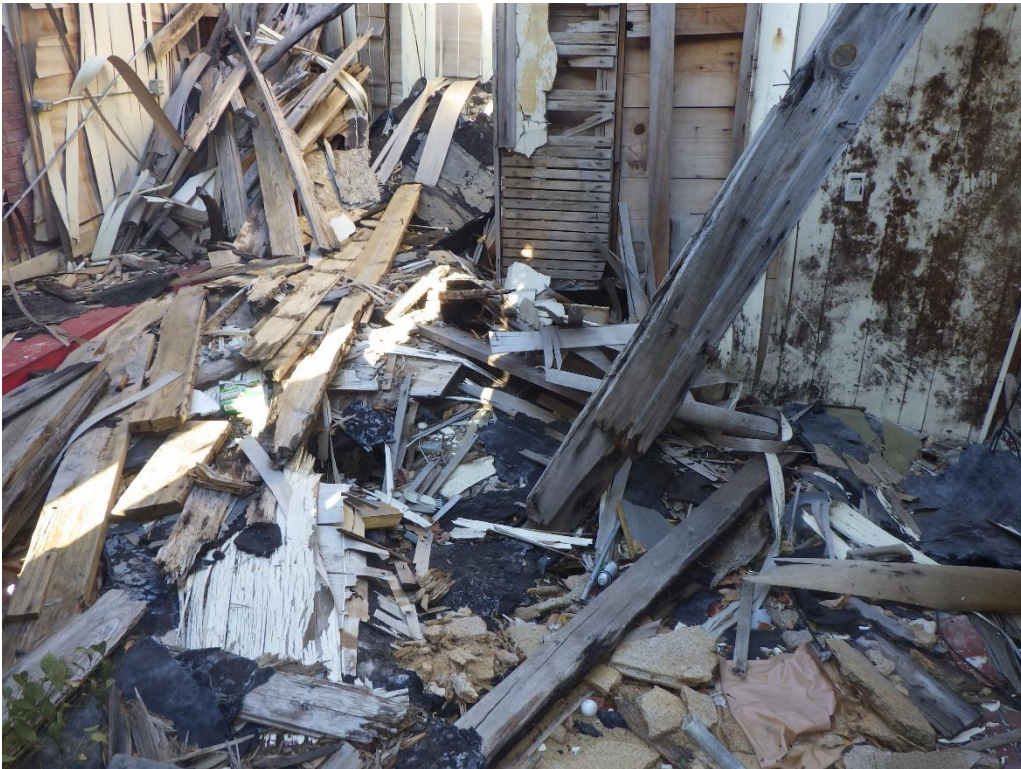
Image 18: Degraded condition of the north floor.

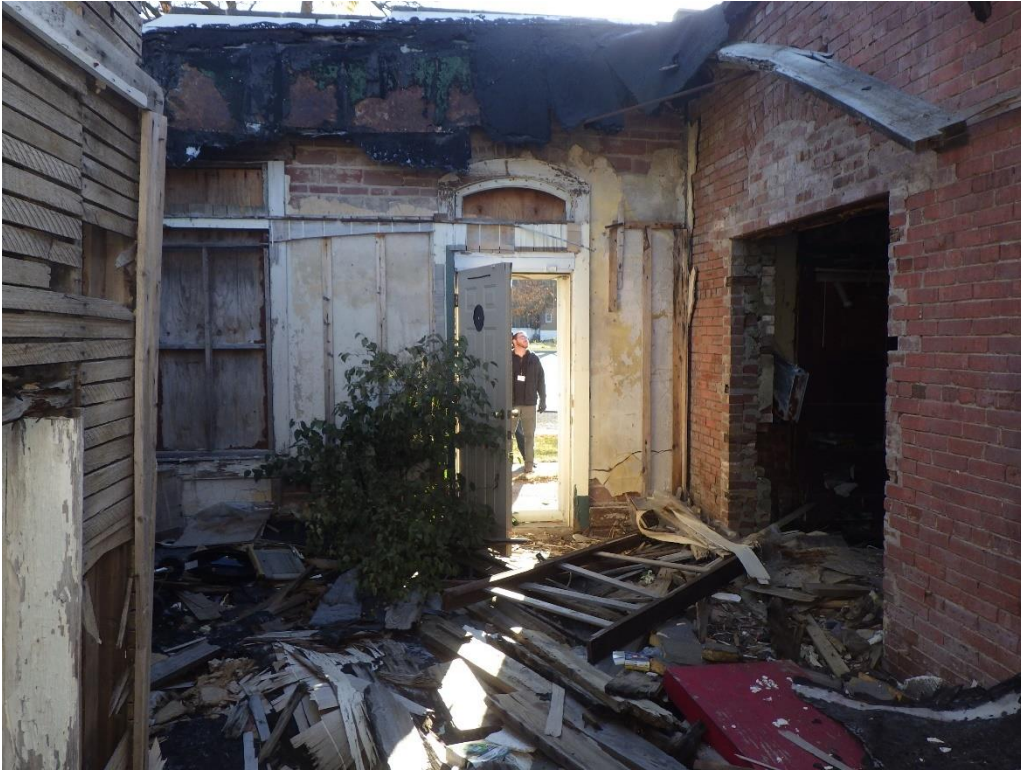
Image 19: East wall unsupported.

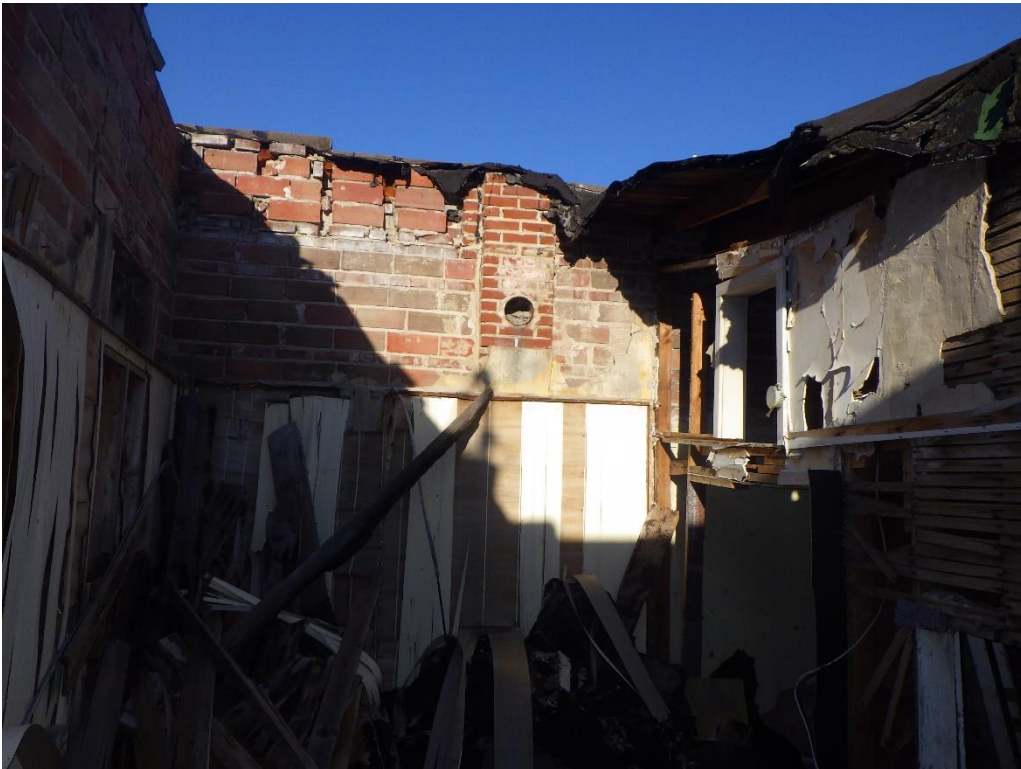
Image 20: Degraded west wall.

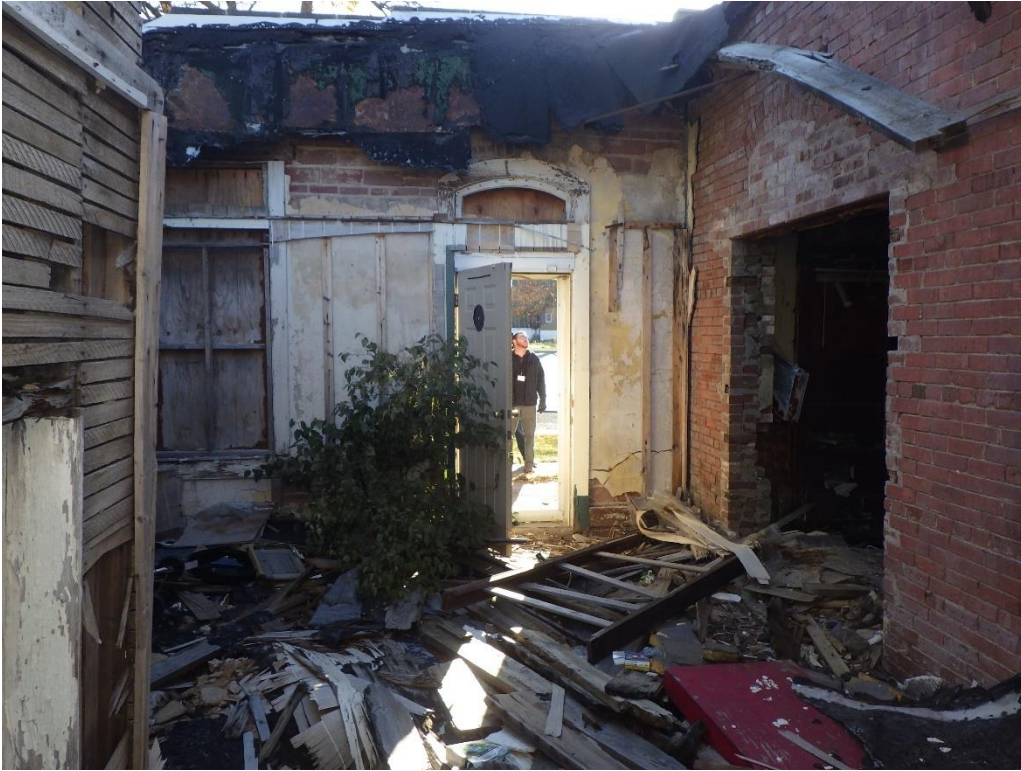
21. A sizable shrub was observed inside the structure (Image 21). The shrub was growing from the debris on the floor.

Image 21: Shrub growing in the debris.
