# Investigative Report

November 17, 2022

RE: Structural Evaluation  
Old Bank Building  
101 Highway 124  
Hallsville, MO 65255

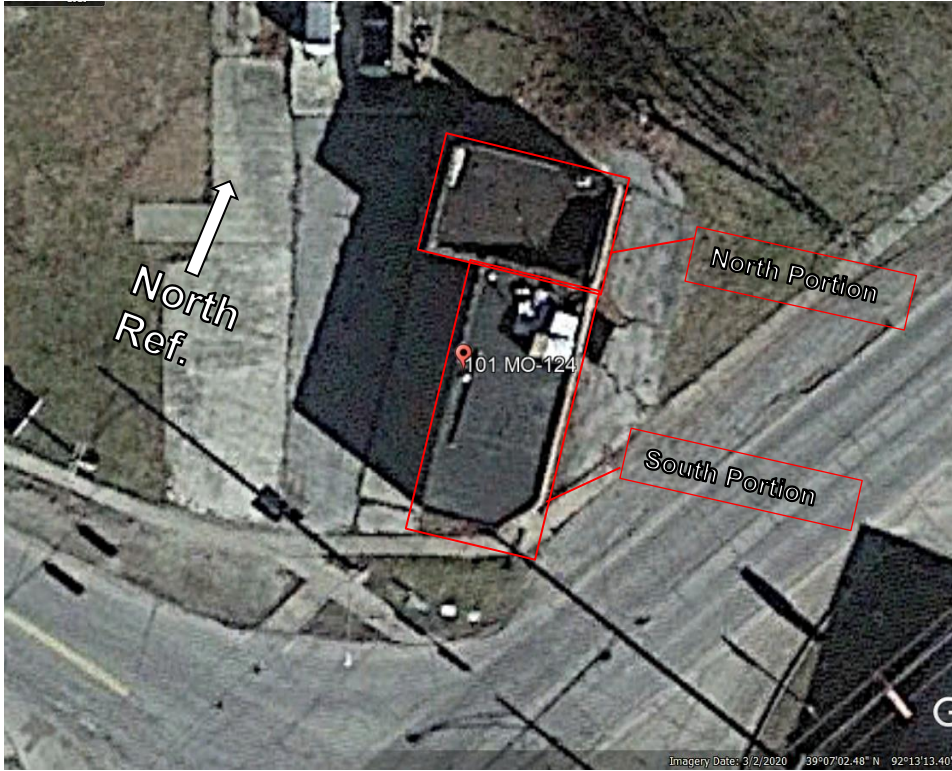
The structure was a single-story, multi-wythe, unreinforced brick masonry building on a crawlspace foundation (Image A). The north portion of the structure had unreinforced clay tile walls. The structure had wood-framed floor and roof assemblies. The mono-slope roof was covered with ethylene propylene diene monomer (EPDM) roofing and drained toward the north. For reference, the front of the structure faced south (Image B).

Image A: Aerial view of the subject structure – credit Google Earth (Imagery Date: 3/2/2020).
